Progress Report on  
**ECOLOGICAL MANGROVE RESTORATION PROJECT**  
IN THE AYEYARWADY DELTA, MYANMAR

**Mangrove Service Network – MSN**  
Yangon, Myanmar. July 2006

**PROGRESS REPORT ON  
ECOLOGICAL MANGROVE RESTORATION PROJECT  
IN THE AYEYARWADY DELTA**

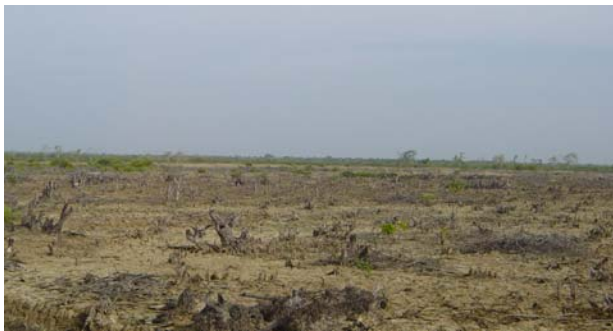
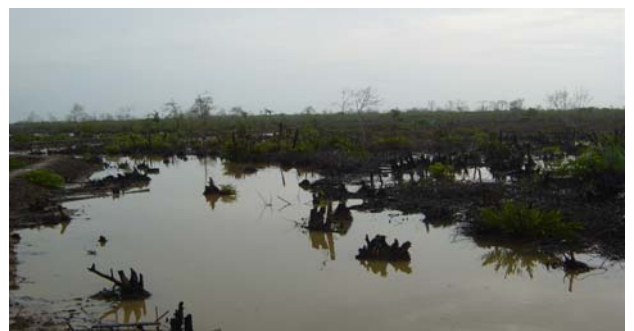
Mangrove Forest in the project area were degraded due to encroachment of shrimp ponds
